Balvac repairs Anlaby flyover

Balvac has undertaken repairs to the Anlaby flyover, which carries the A1105 Anlaby Road, one of the main access routes into Hull City Centre and the KC Stadium.

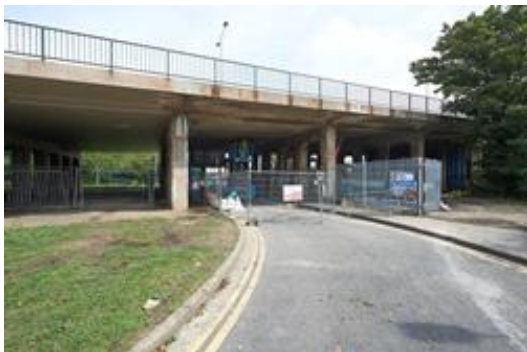
Constructed in the early 1960s, the 376m-long reinforced concrete structure was suffering with concrete delamination from years of severe saline attack caused by road salts. In places, the condition of the concrete was so deteriorated that sections had fallen away, exposing the internal steel reinforcement.

Balvac was awarded the contract following a competitive tendering process and began the repairs in May 2014. In accordance with the client's specification, Balvac carried out 36m³ of concrete repairs utilising the Sika range of materials which included Sika Armorex Armorcrete for the poured repairs, Sika Monotop 612 for the hand repairs and Sika Cem Gunitite 133 for the spray applied concrete repairs.

Incorporated into the repairs were over 2,500 Vector Galvashield Anodes which provide cathodic protection against future reinforcement corrosion. The concrete was additionally protected with the application to over 2,500m² of Sika Ferrogard 903 corrosion inhibitor, while Sika Guard 550 W, a protective elastomeric coating, was applied to 9,000m² of concrete surfaces.
