## **CASE STUDY: Concrete Spalling Remediation Programme**

### **EDF Energy, Hinkley Point B Power Station, 2017**

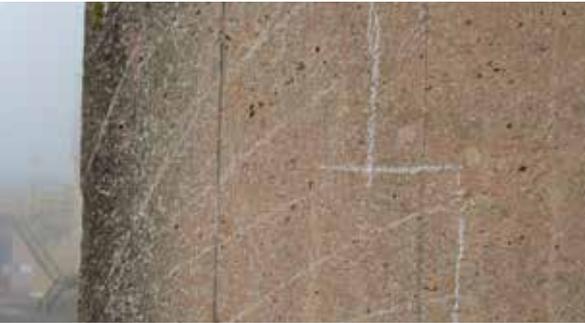
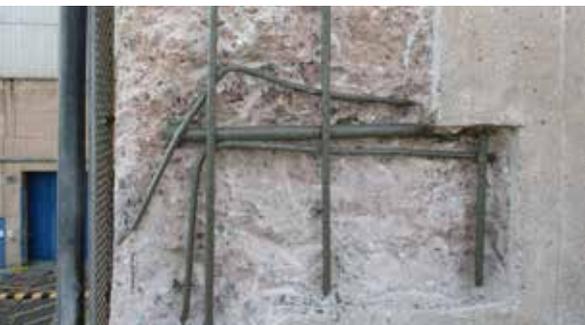
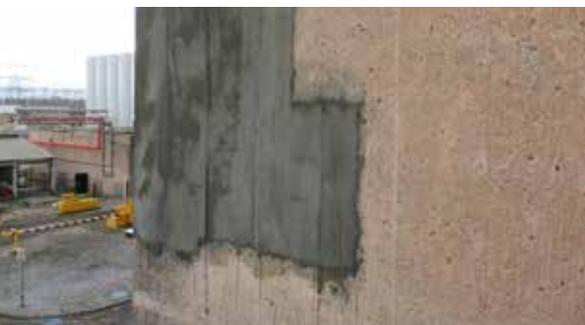
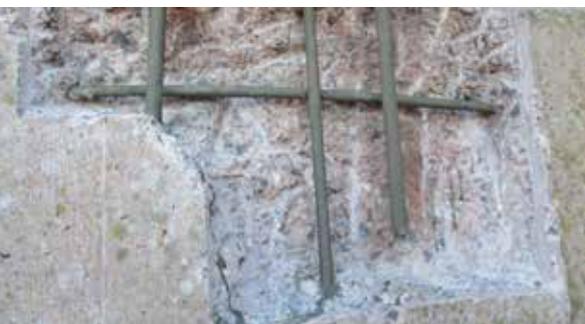
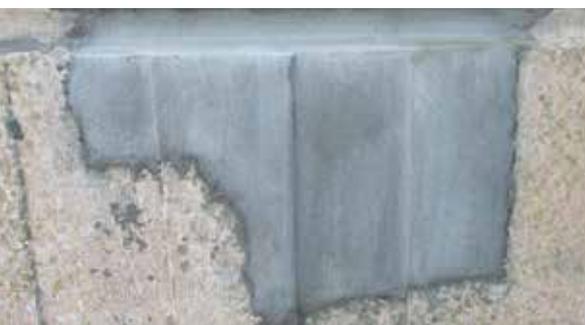
A combination of environmental exposure, water ingress and the age of the station building, had caused spalling in areas, including the flask bay and turbine hall.

Images from the work undertaken are shown.

A range of protective coatings were used to protect the structures from moisture intrusion and further corrosion, reducing the need for ongoing maintenance work for the life of the station.
