CASE STUDY: Pumping Station Wet Well Refurbishment

Anglian Water, 2017

CSC Services refurbished a sewer pumping station wet well in February 2017 for Anglian Water.

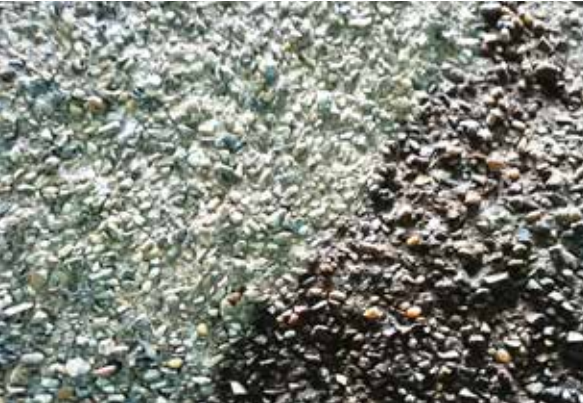
The structure had suffered from significant hydrogen sulphide corrosion to the internal concrete surfaces, and had been taken out of service.

The first image shows the profile of the corroded concrete surface prior to refurbishment work.

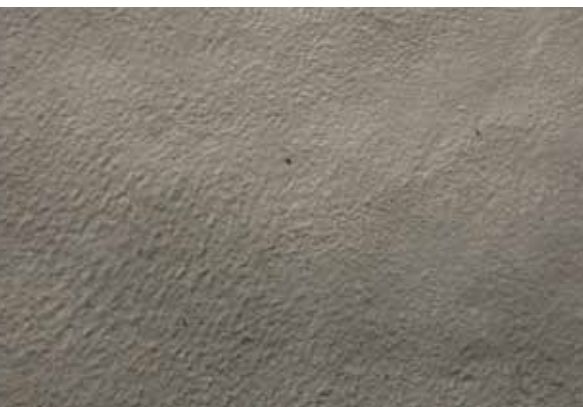
The second image shows the profile of the refurbished concrete surface following application of the cementitious coating system.

Following high pressure water jetting off internal surfaces and removal of debris, a high strength structural repair mortar was applied to the concrete surfaces. A water based cementitious coating system was installed over the repair mortar to provide a hard, durable coating with excellent resistance to water and hydrogen sulphide. With greatly enhanced chemical resistance this system was specified for the protection of concrete offered in sulphate contaminated conditions. This will significantly extend the life-span of the structure.

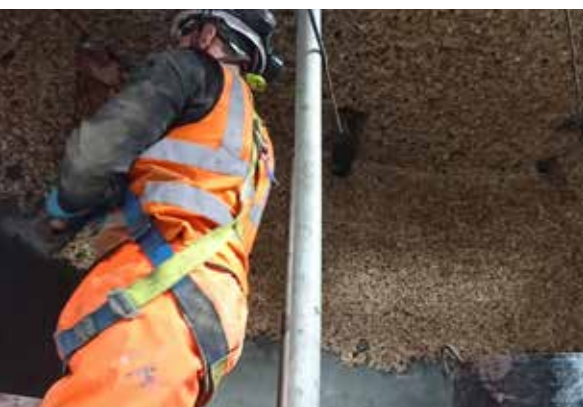
The third image shows a CSC Services Operative installing repair mortar to the wet well. The bottom section of the wet well is complete.

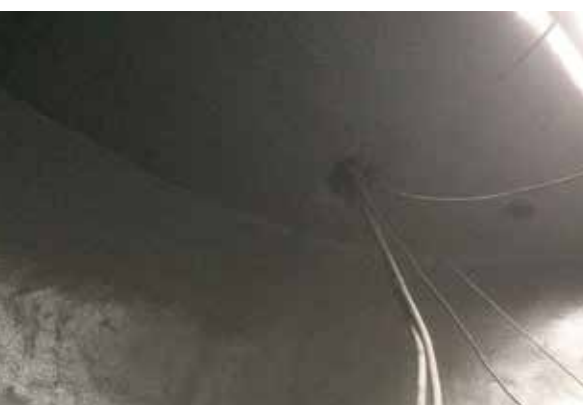
The final image shows the wet well following full refurbishment, prior to final inspection and full return to service.
